Manhole Inspection Summary

Manhole # S61I__025MH

Insp Date: **3/24/08 10:51 AM**

Location Address: **501Savage St.**

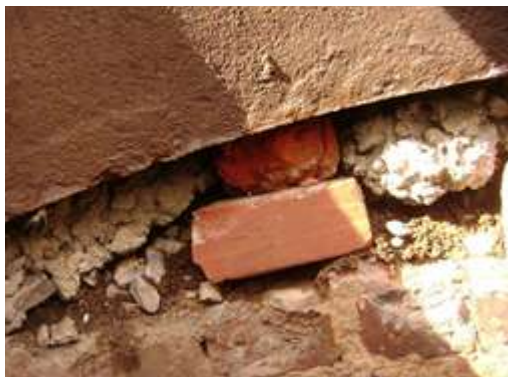
Defect 2

Condition: ☐ Sound ☐ Cracked ☐ Root Intrusion ☒ **Loose Brick** ☒ **Deteriorated**

Infiltration: ☐ None ☒ **Joint** ☒ **Cracks** ☒ **Mortar** ☐ Roots ☐ Wall

Loose bricks at frame adjustment.

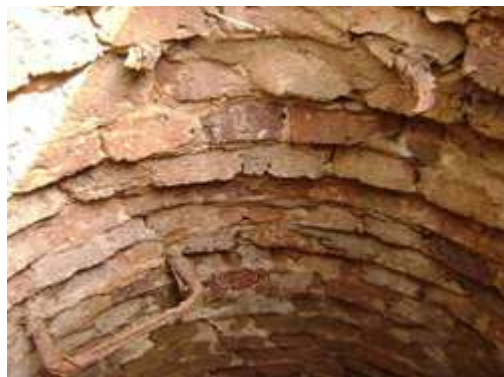
Defect 3

Infiltration: ☐ None ☐ Joint ☐ Cracks ☒ **Mortar** ☐ Roots ☐ Wall

infiltration at barrel (bottom edge of picture)

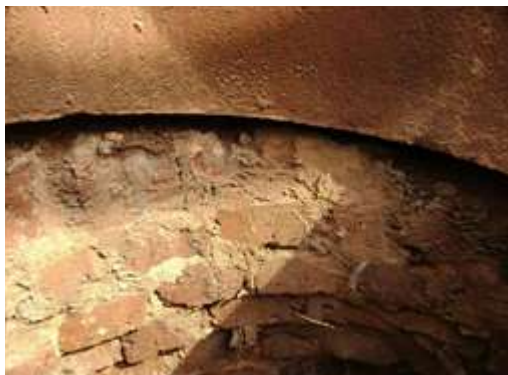
Defect 1

DETERIORATION JOINT.

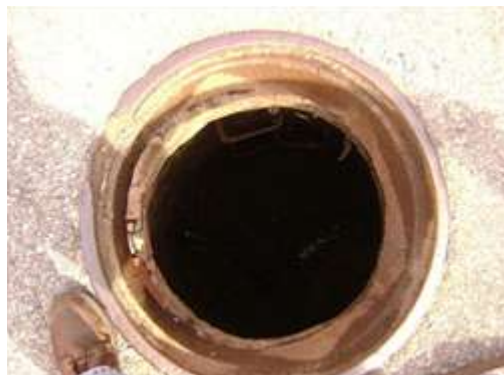
Defect 4

Offset: **2** (in.)

Frame offset defect

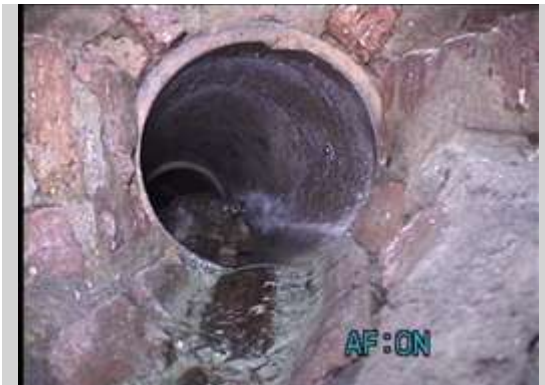
3 O'Clock Inflow

Pipe Height: **8.4** (in.) Rod and Bar (Angled)
Pipe Material: **Clay** ☐ Pipe Lined
Invert Depth: **8.17** (ft.) Flow Characteristics: **Slow**
Deposits: ☐ None ☐ Mud ☐ Sludge ☒ **Debris** ☐ Grease
Silt Depth: **3** (in.) Deposits Extent: **Medium**
Infiltration: **None** Pipe Seal Cond: **Sound**
